# **Navajo Abandoned Uranium Mine Site Screen Report**

## **Largo AUM Site**

### **Navajo AUM Eastern Region**

**May 2009**

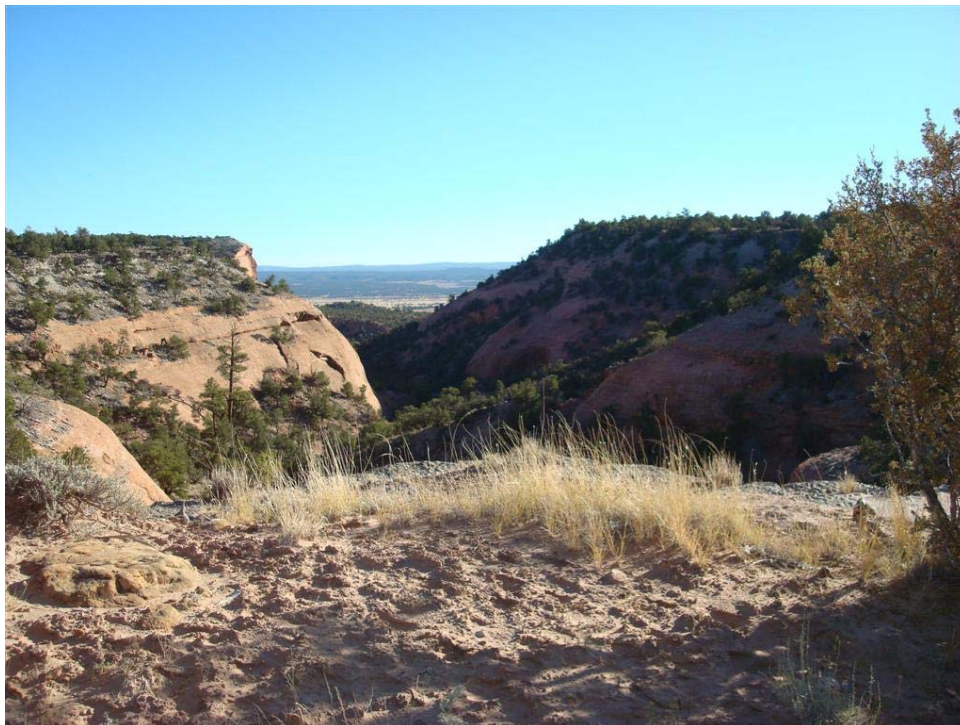
Reclamation status of the mine site is currently unknown. No visible signs of reclamation of mine workings were observed. The mine is located above a box canyon with drainage towards the south with residences located one mile down stream. No waste piles, adits, or other mine features were observed during the site visit.

Photo 1. Largo Mine site, towards the south

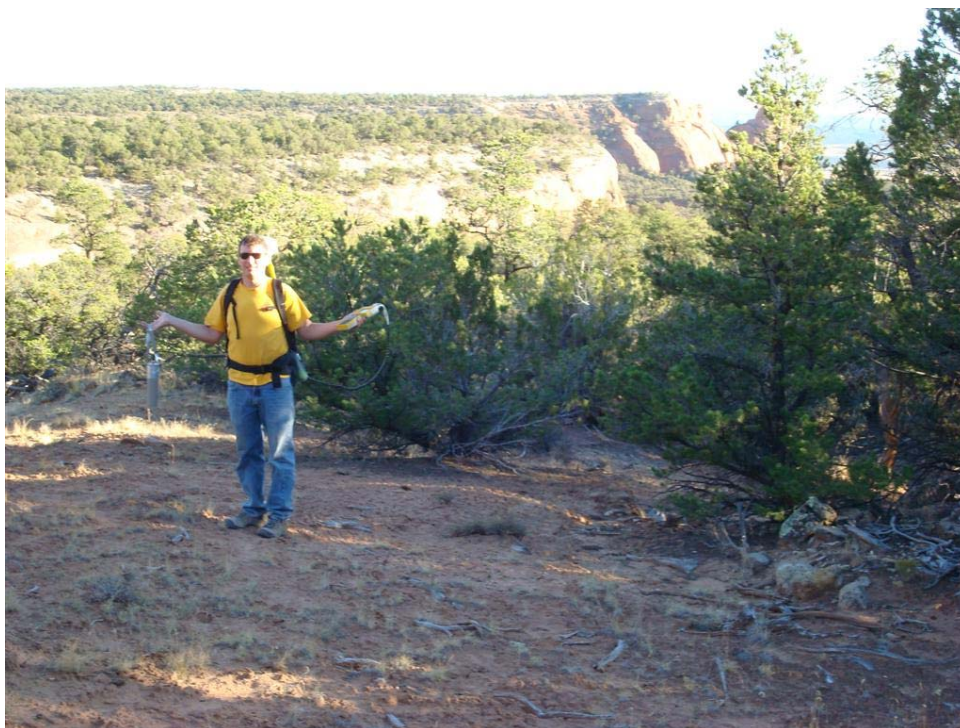
Photo 2. Largo Mine site, towards the east

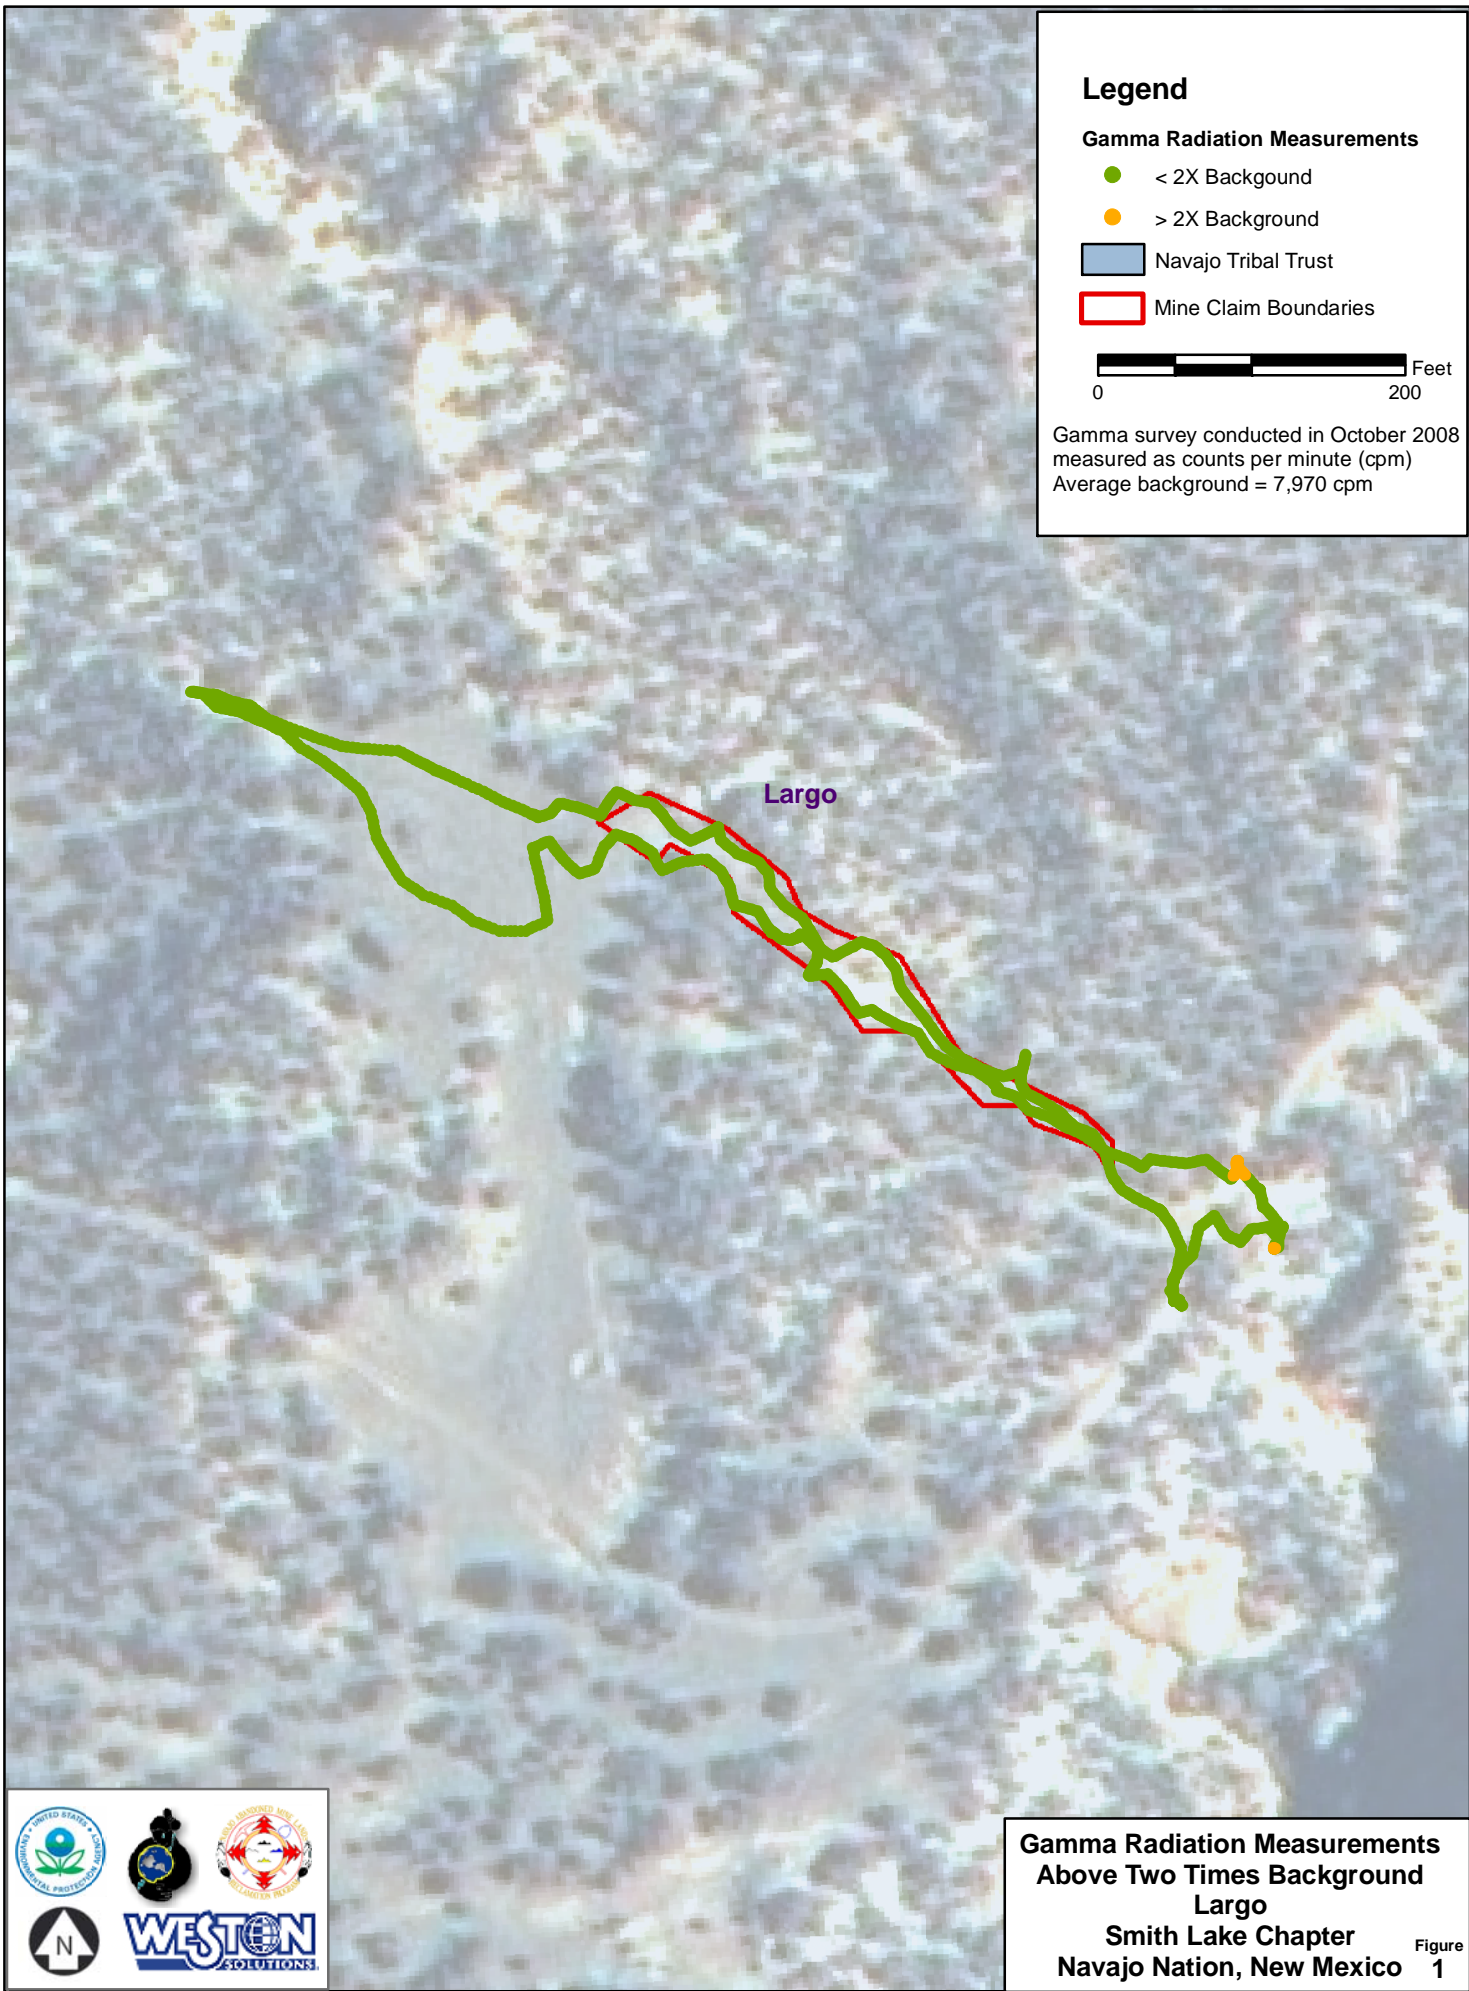
Figure 2

A total of 1,105 gamma radiation measurements were collected from mine sites, ranging from 5,722 cpm to 91,911 cpm. The measurements are represented in Figures 1 and 2.

Gamma survey conducted in October 2008  
measured as counts per minute

Gamma Radiation Measurements  
Largo  
Smith Lake Chapter  
Navajo Nation, New Mexico
